# **Rochester Intermodal Station Project**

## **PIN 4936.04**

### **Evaluation of the 1914 Pedestrian and Baggage Subway Tunnel under CSX Running Tracks**

April 2012

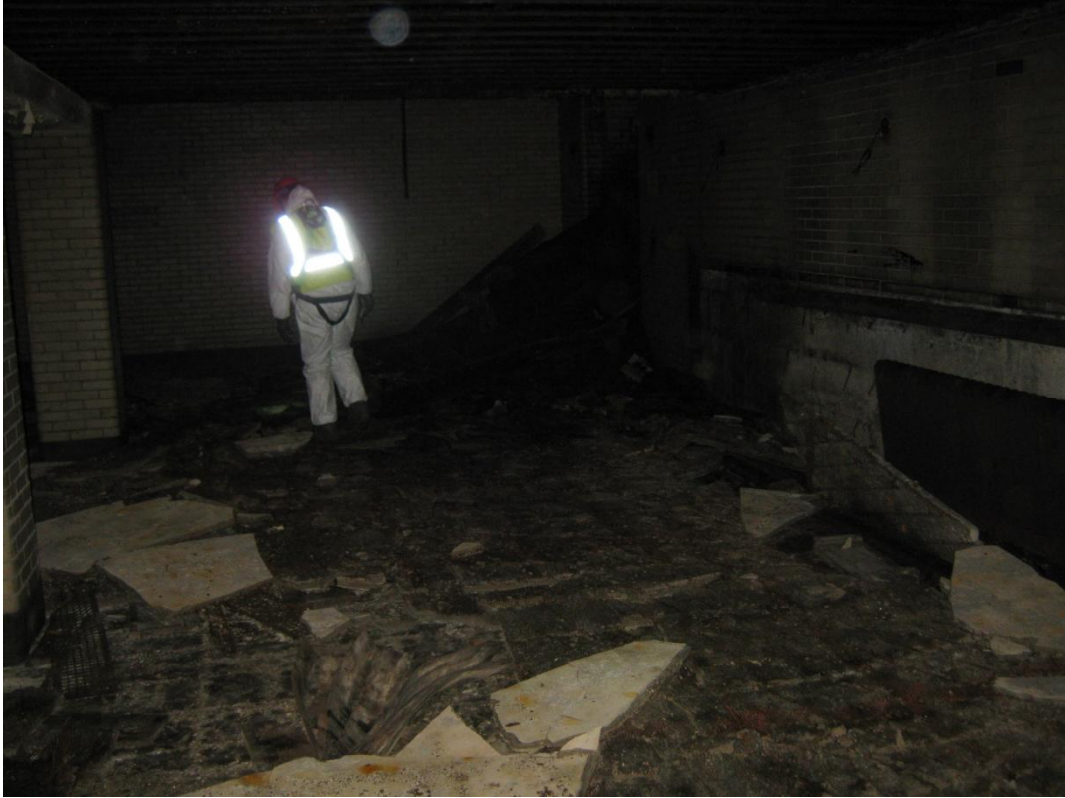
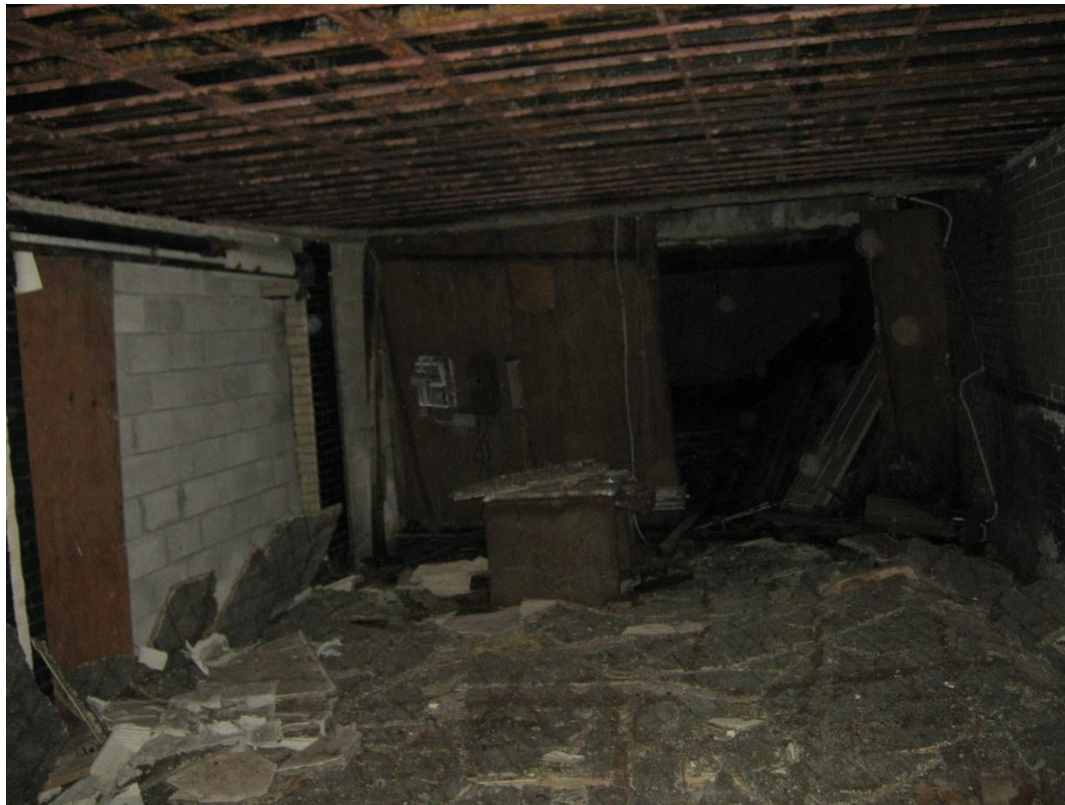
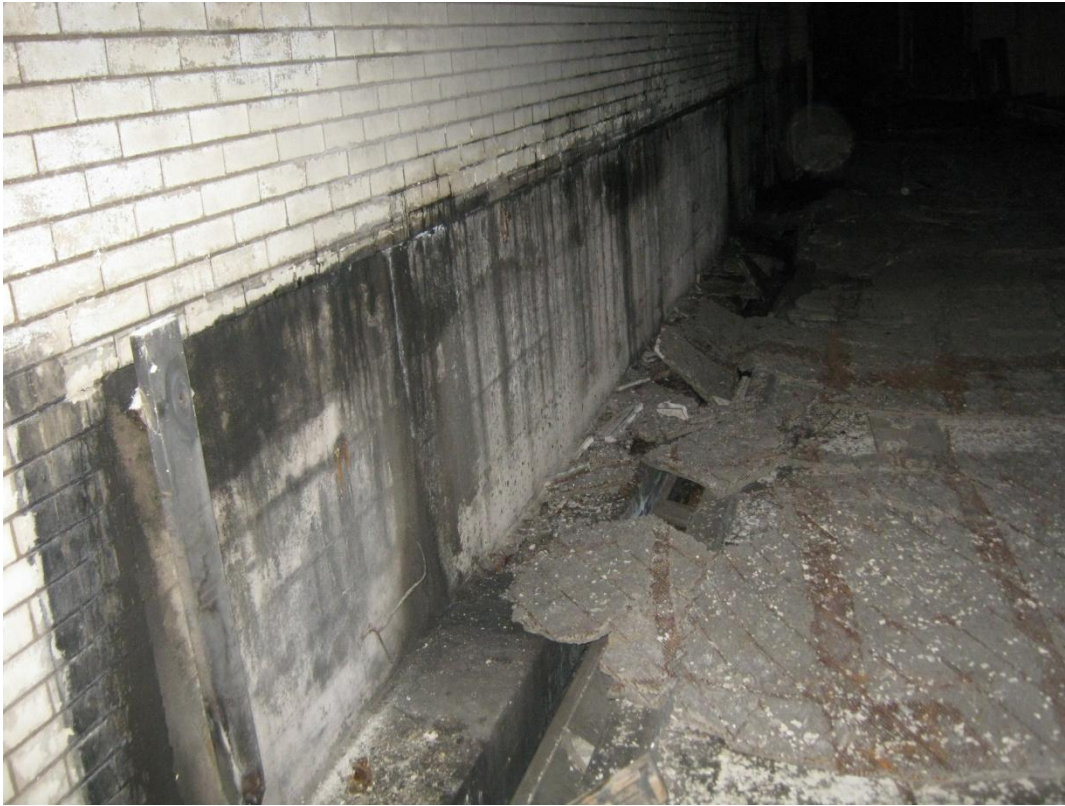
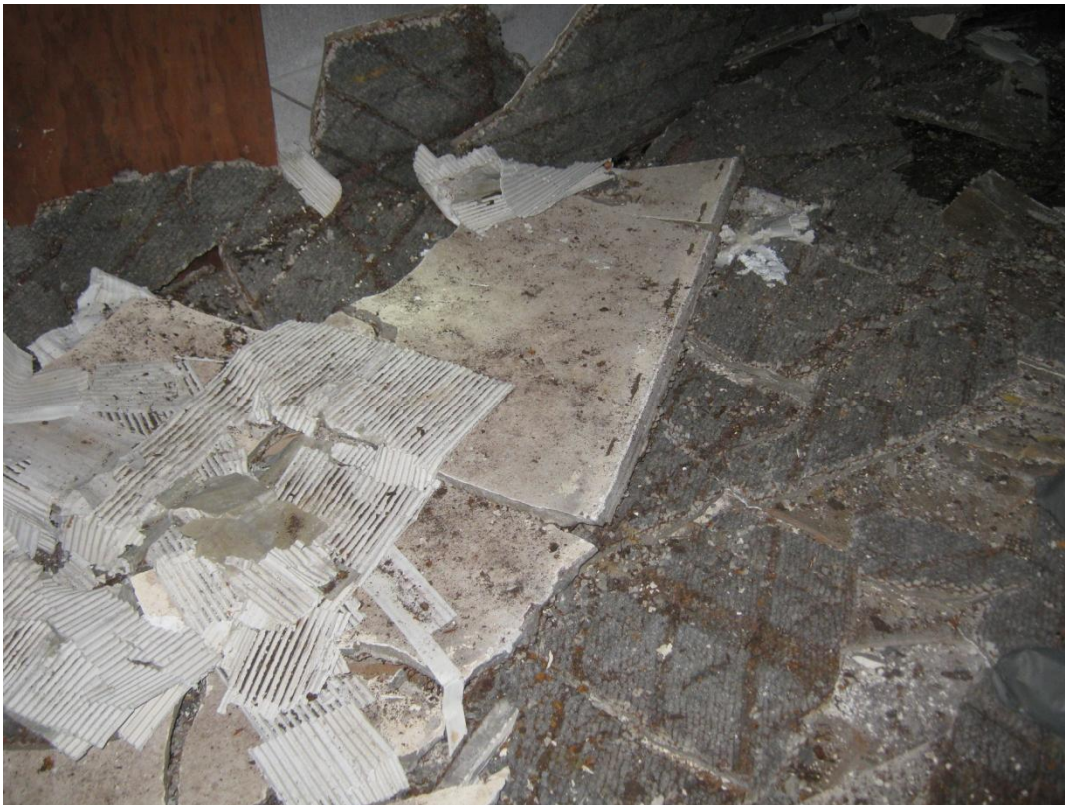
The inside of the passenger subway tunnel appears to have been abandoned with loose building materials and debris scattered throughout (Appendix A: Photos 1-4). The majority of the ceiling plaster has separated from the metal supports and now covers most of the tunnel floor (Appendix A: Photos 5-8). The stairwells have been filled to prevent access, and the south end of the tunnel which once connected to the original Station building has been bulk headed with concrete blocks (Appendix A: Photos 9-12).

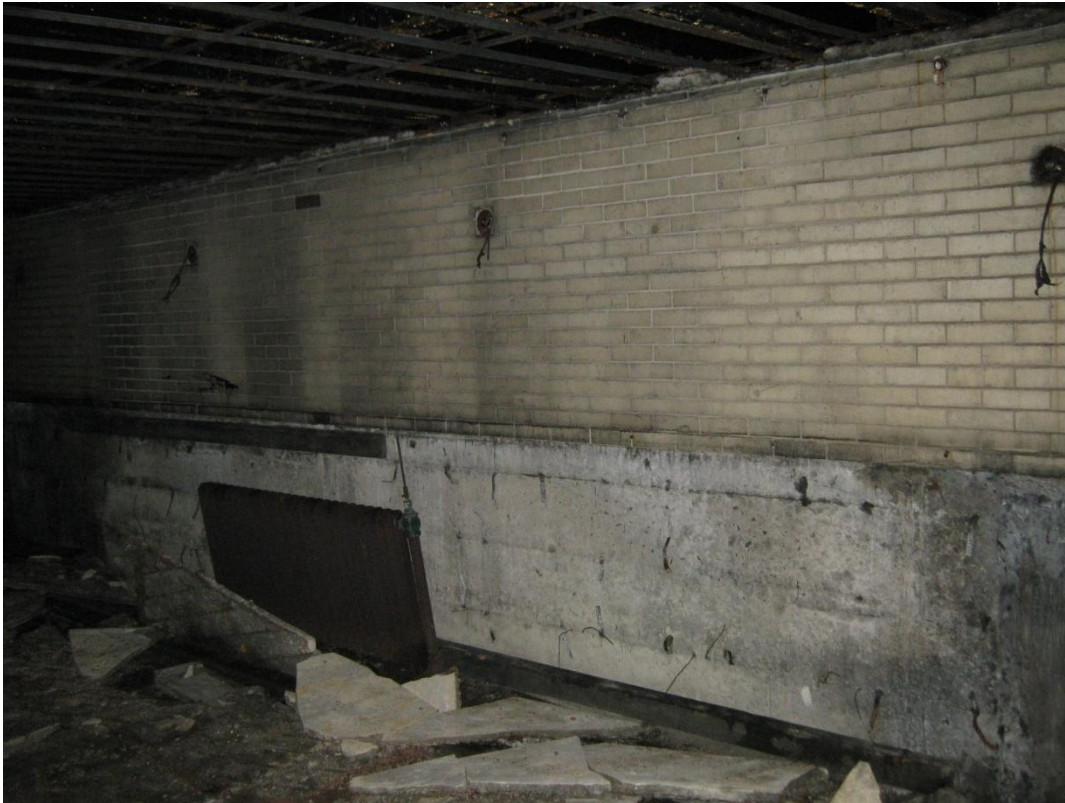
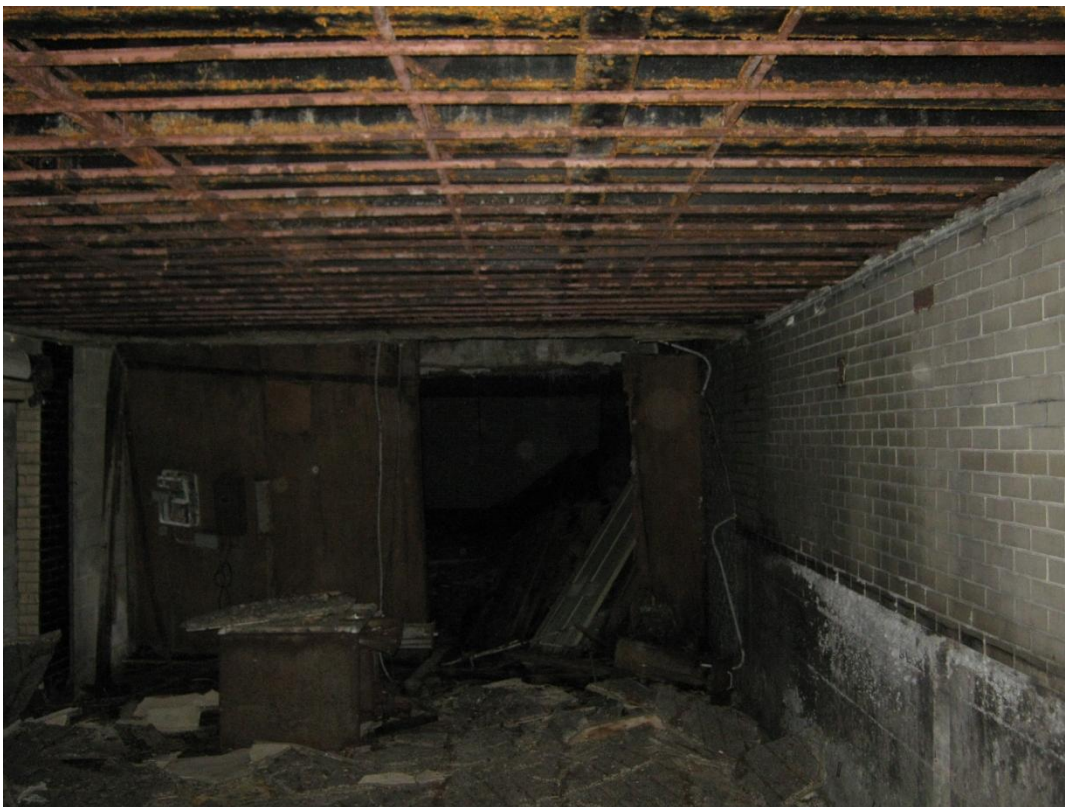
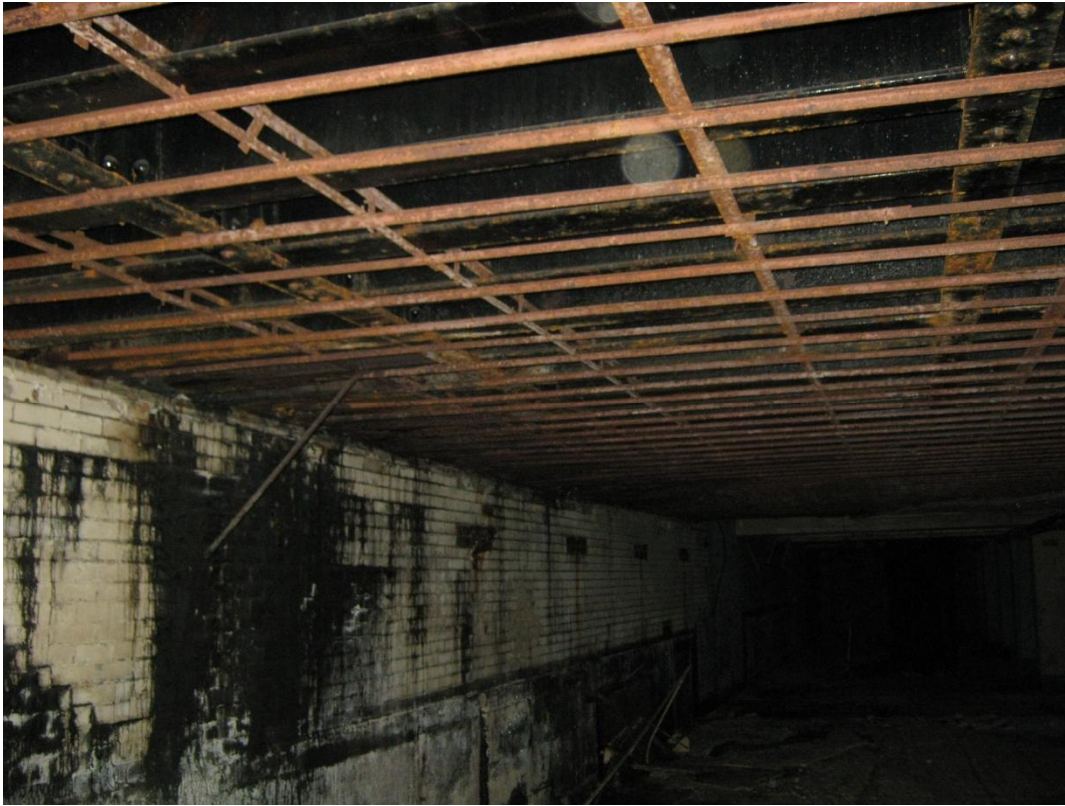
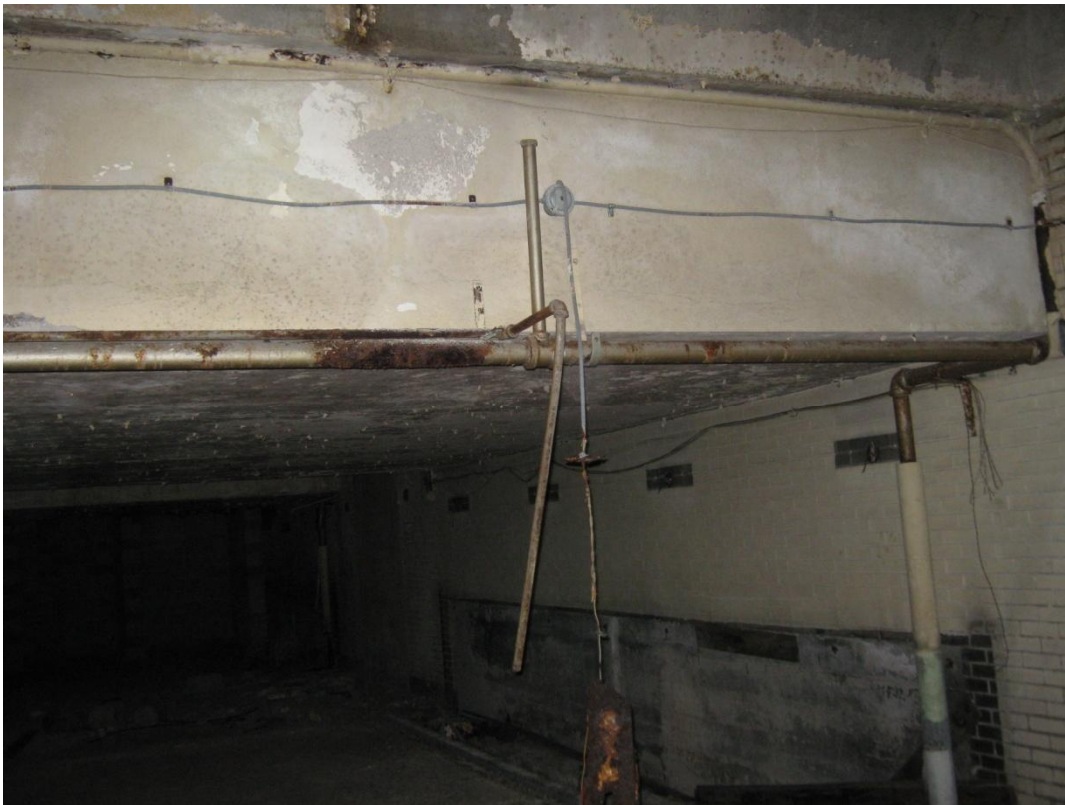
The concrete tunnel walls are generally in fair to good condition with minor deterioration found along the top supporting seat of the roof structure (Appendix A: Photos 13-16). All of the columns along the center of the tunnel that support the central girder are in good condition with no apparent evidence of structural distress due to heavy loading associated with the roof dead loads and railway traffic (Appendix A: Photos 17-20).

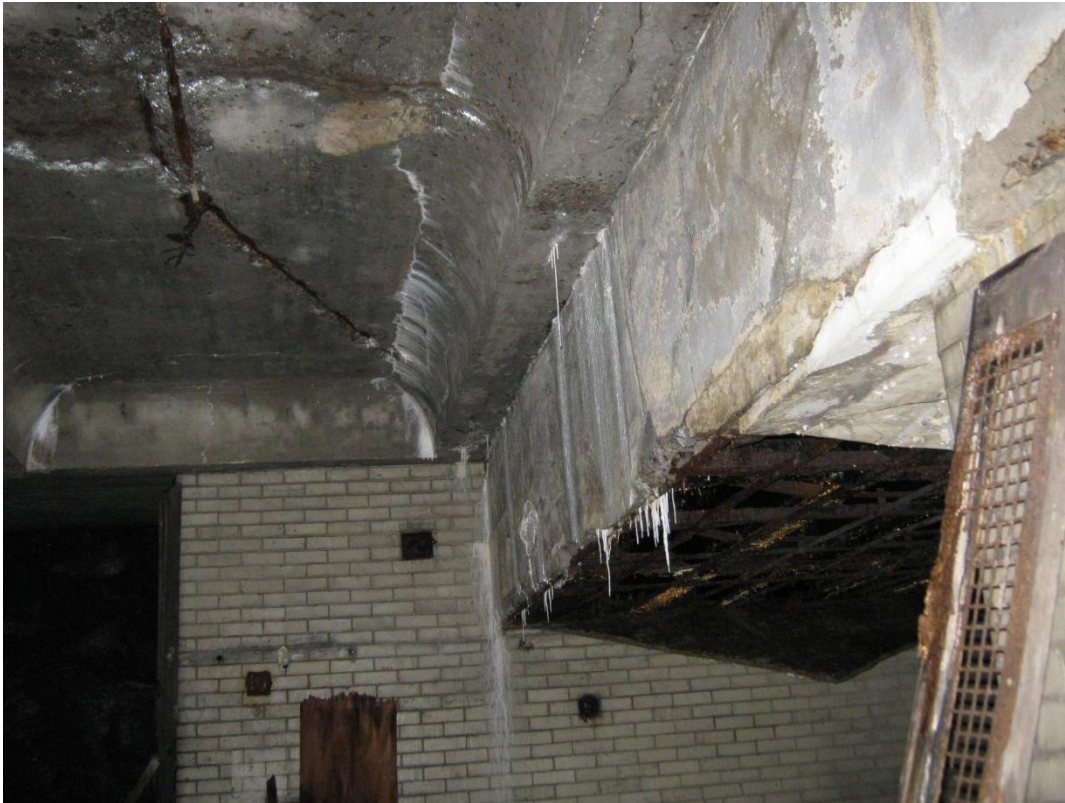
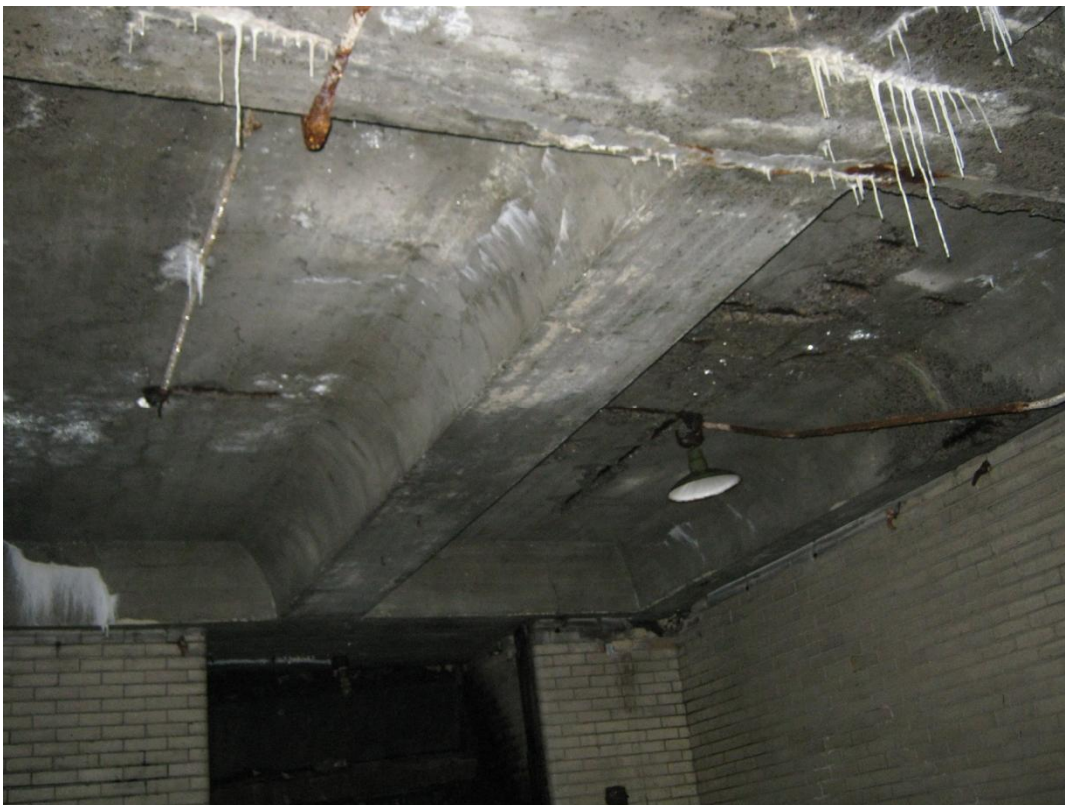
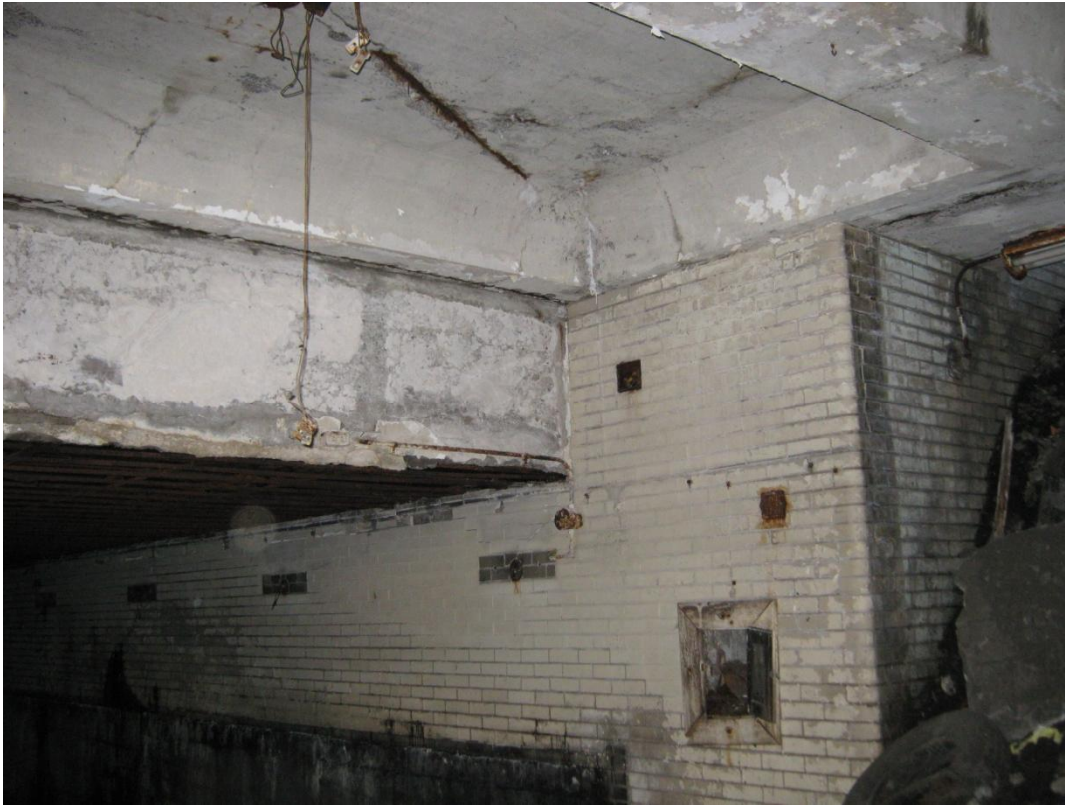
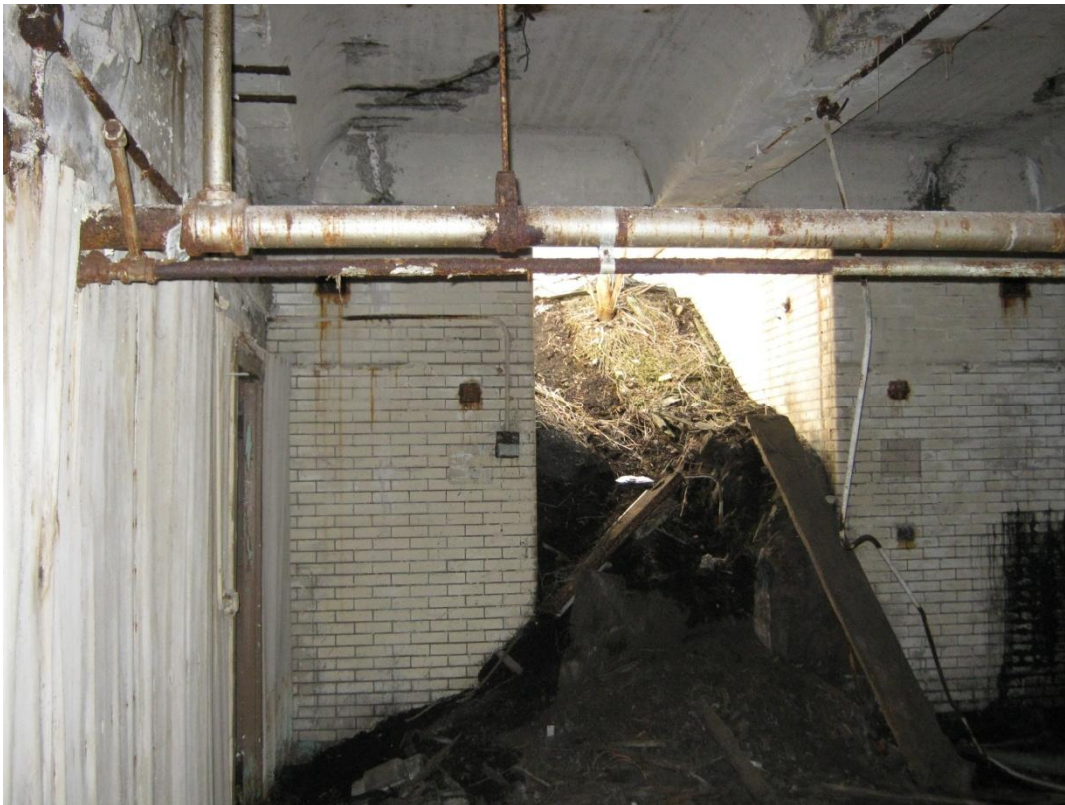
The roof structure of the passenger tunnel below the platforms is in fair condition with minor deterioration. Typical deterioration consists of 1.5" to 2" deep spalling with exposed reinforcing bars, minor shrinkage cracking with efflorescence staining, and some minor active leakage (Appendix A: Photos 21-24).

The 1914 passenger and baggage subway tunnels beneath the operating CSX tracks north of the existing Rochester station building are now 98 years old. The construction details and age have led to water infiltration. Repair of the water infiltration could be a significant and costly undertaking since it would involve the temporary relocation of the overlying tracks, removal of ballast and overburden, and reconstruction and resealing of the tunnel roof system. In addition to repair of the tunnel roof system, various repairs to the structural members within the tunnels to repair cracks, spalls and deteriorated structural steel would also be required.

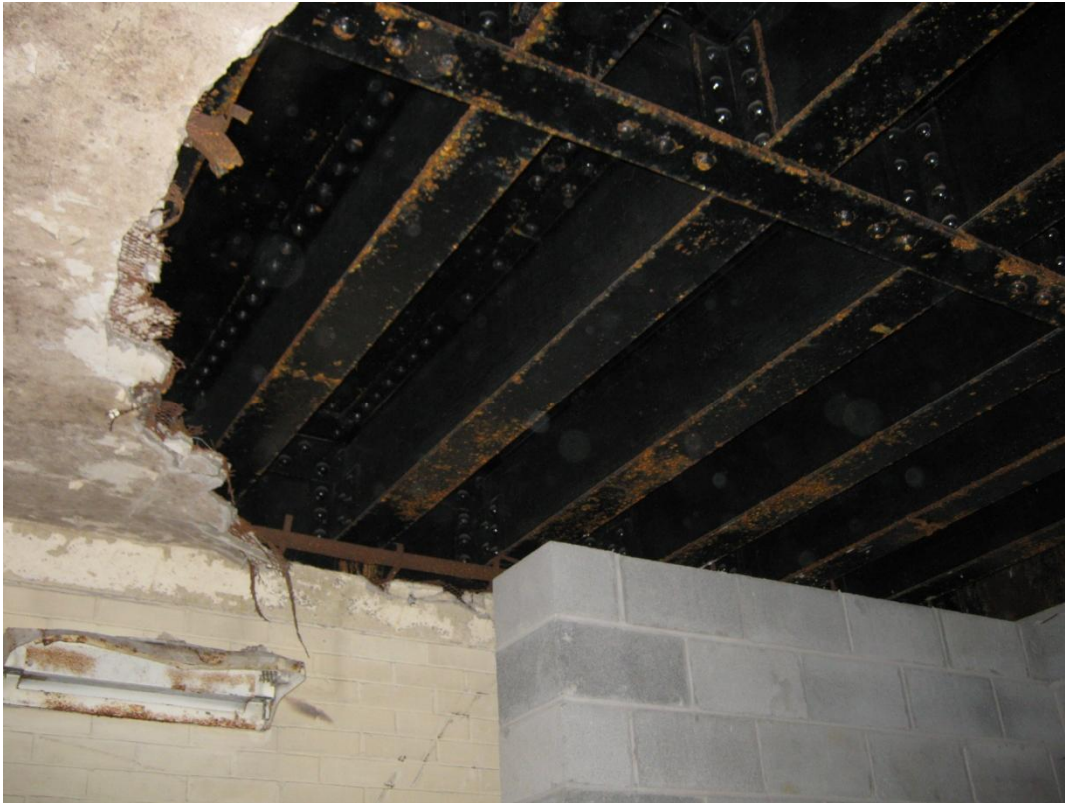
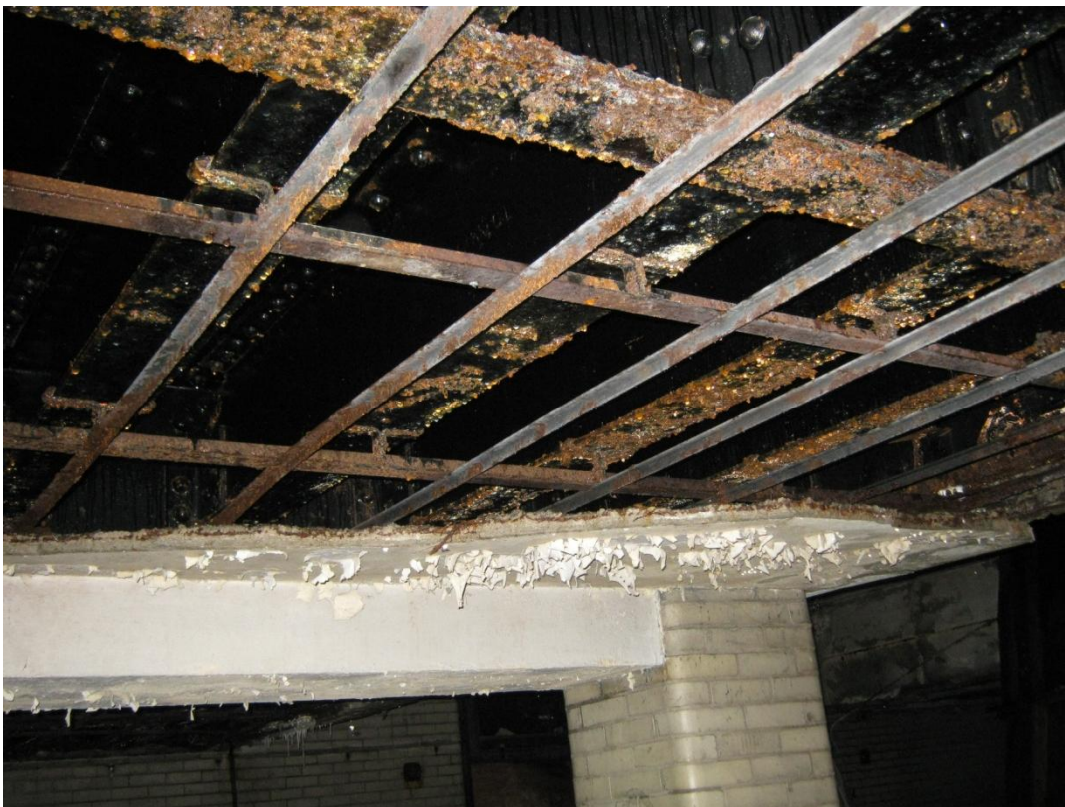
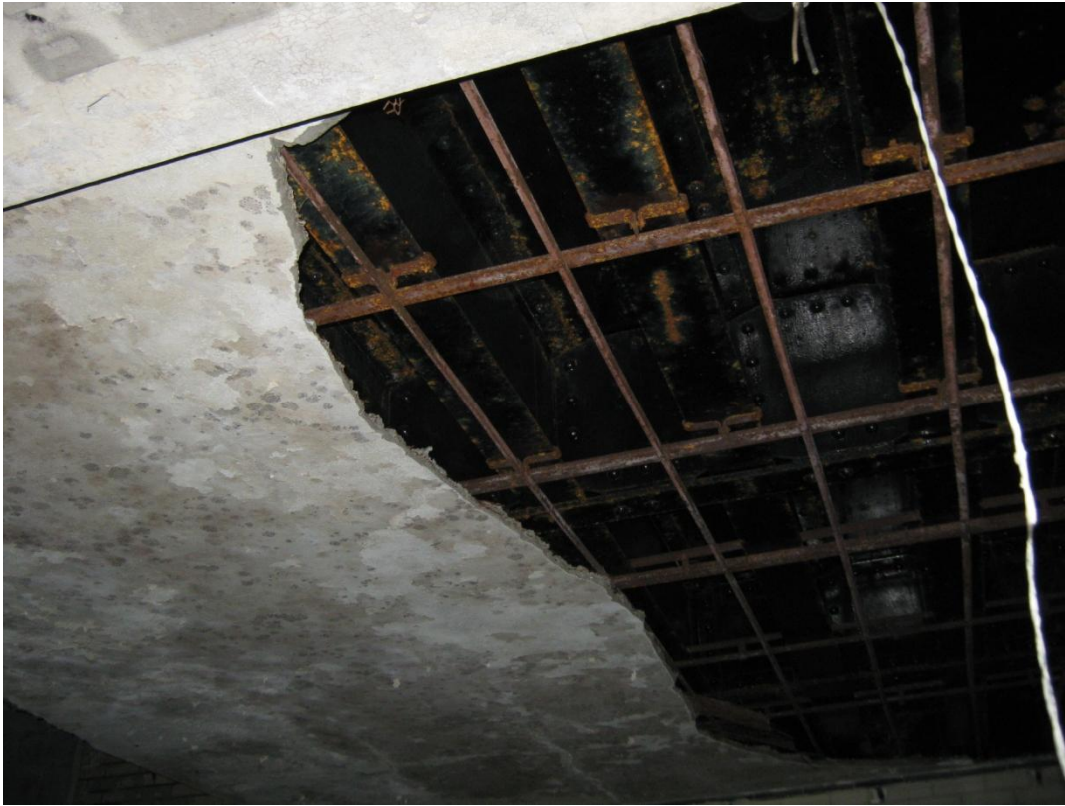
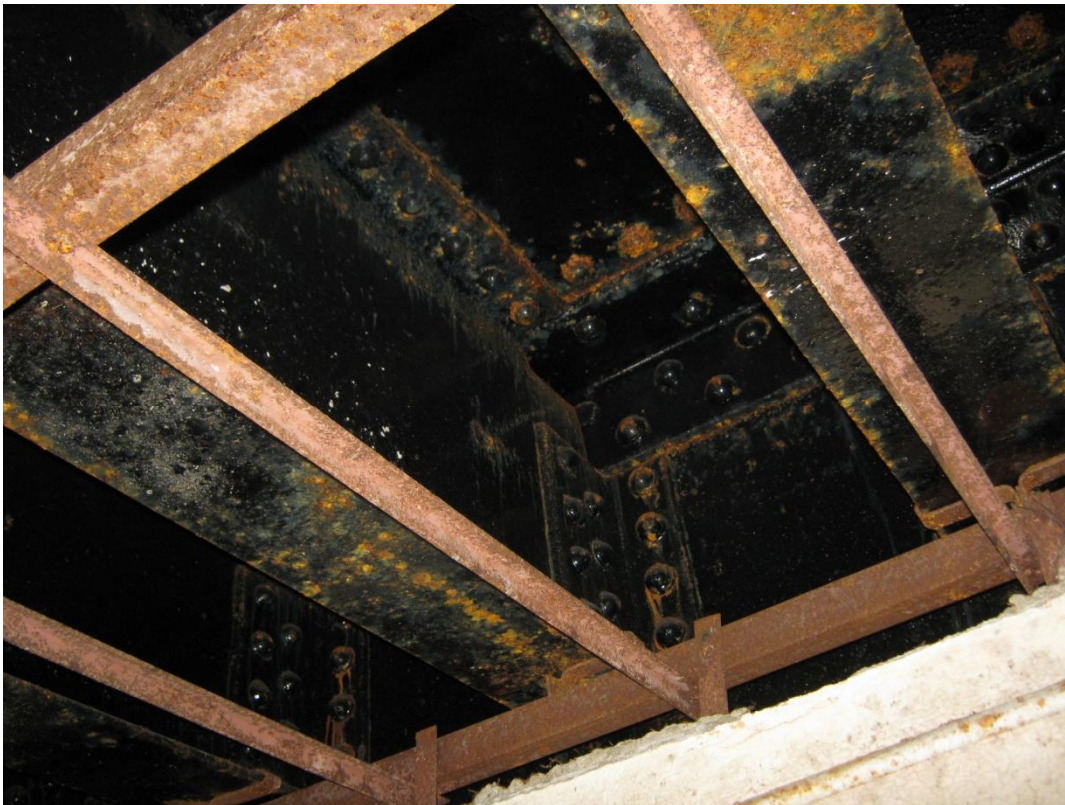
The roof system and supporting structure of the passenger tunnel below the tracks is generally in good condition with minor corrosion to the supporting steel. There is no apparent evidence of active leakage and much of the original steel coating system is in fair to good condition (Appendix A: Photos 25-28).

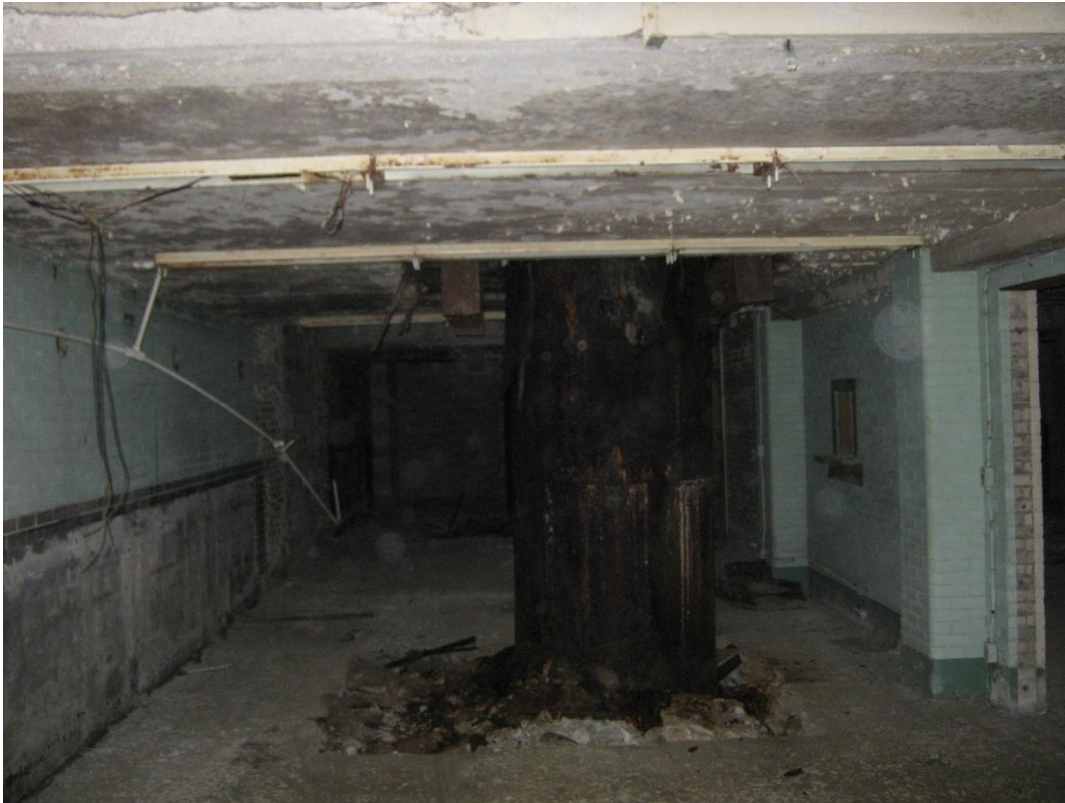
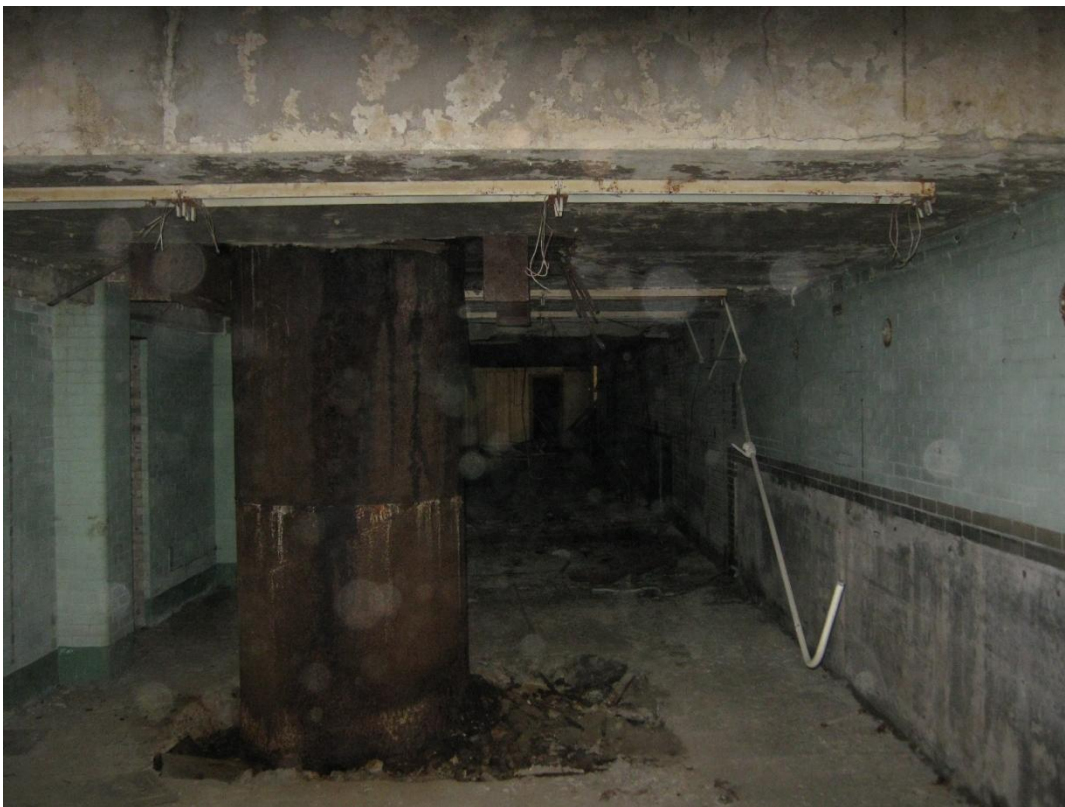
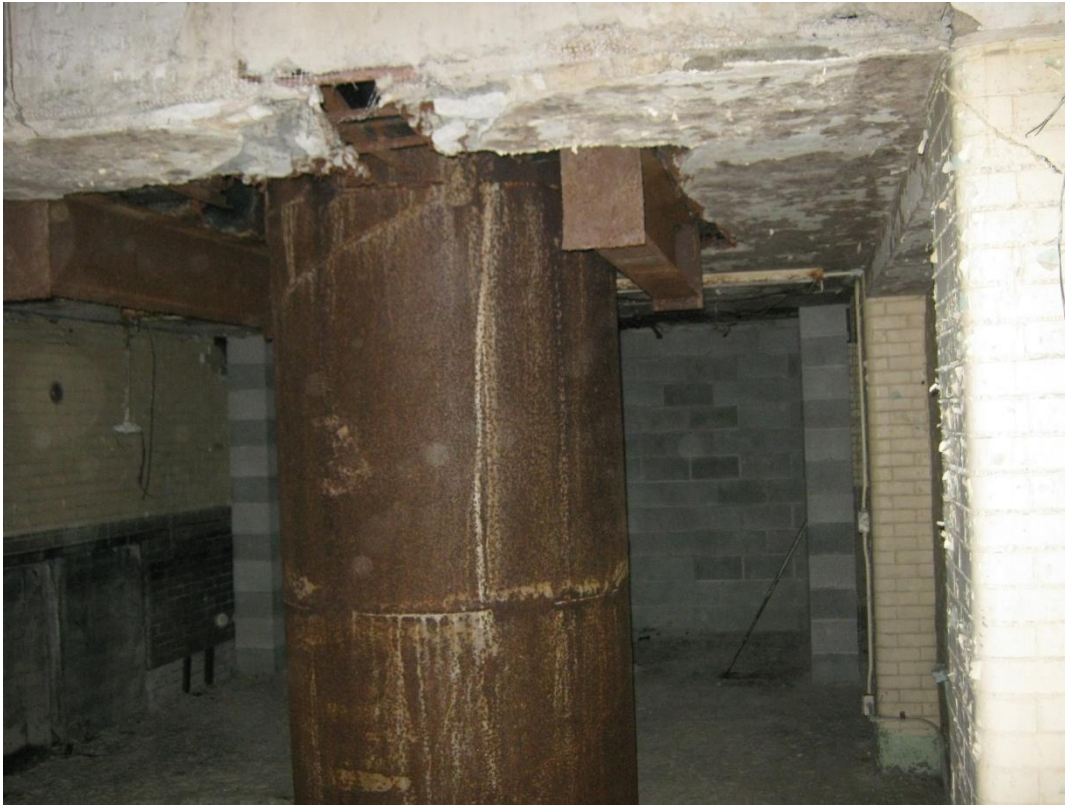
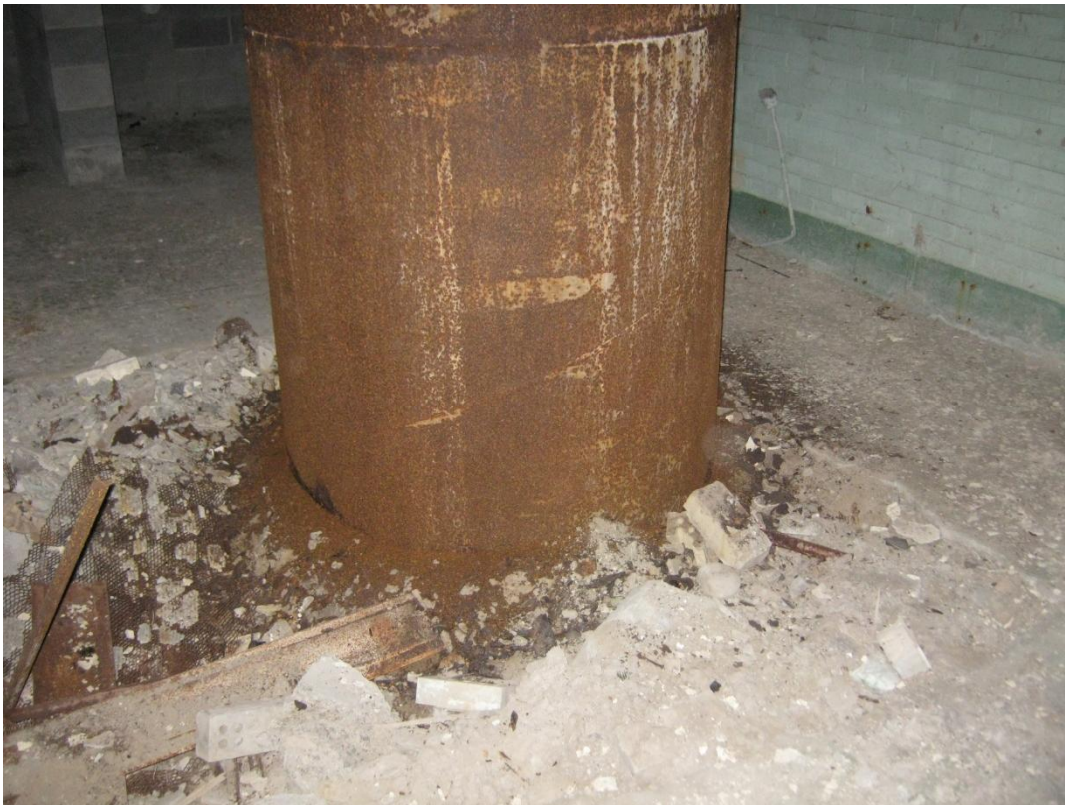
Two steel casings approximately 4 feet in diameter were located near the southeast end of the tunnel. They appear to be positioned beneath the Amtrak building and it is assumed that they support two of the building's interior columns (Appendix A: Photos 29-32).

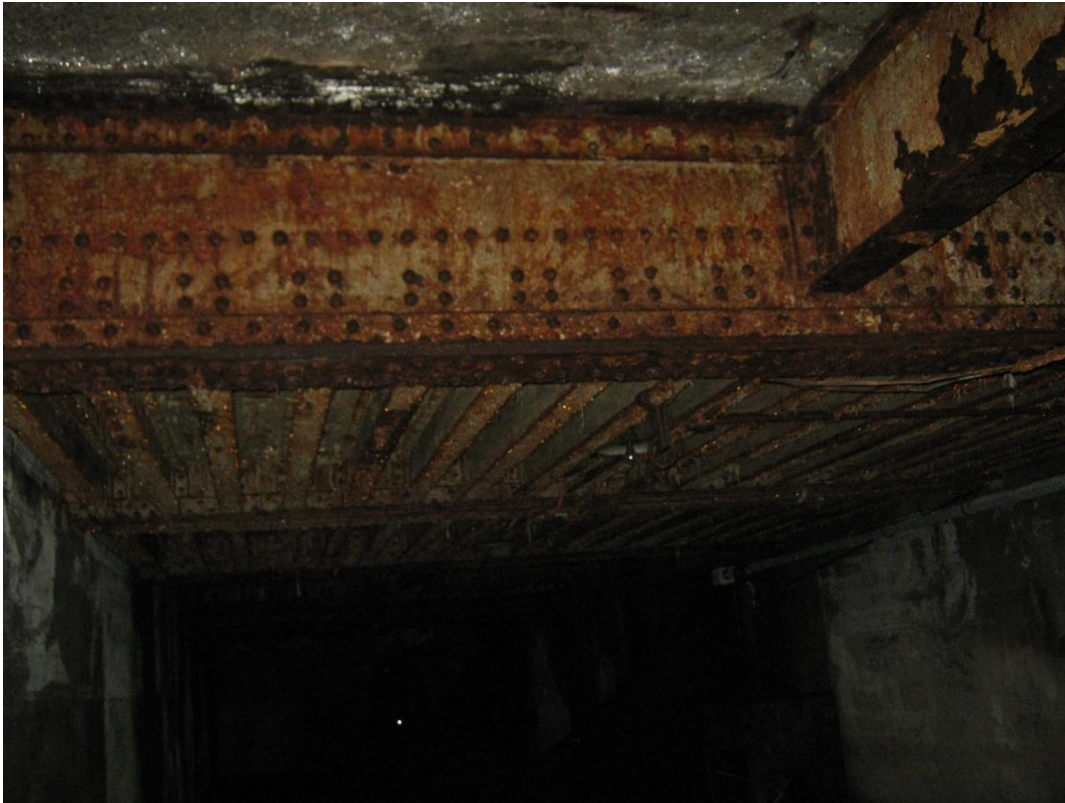
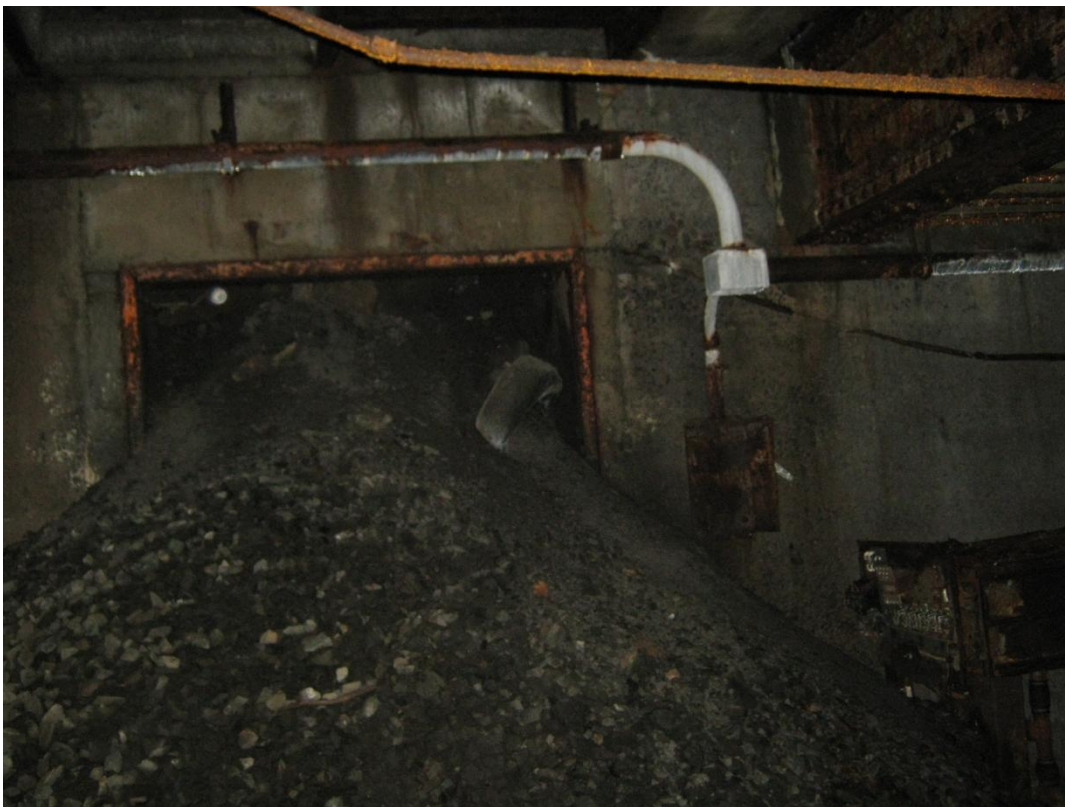
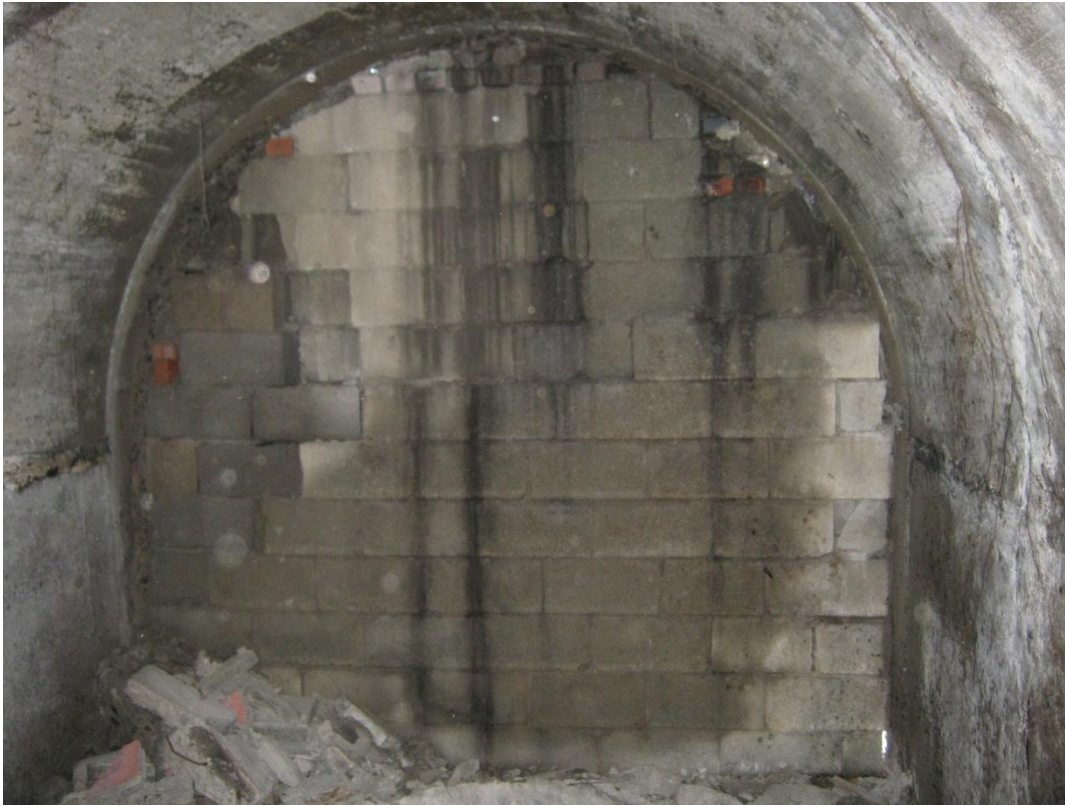
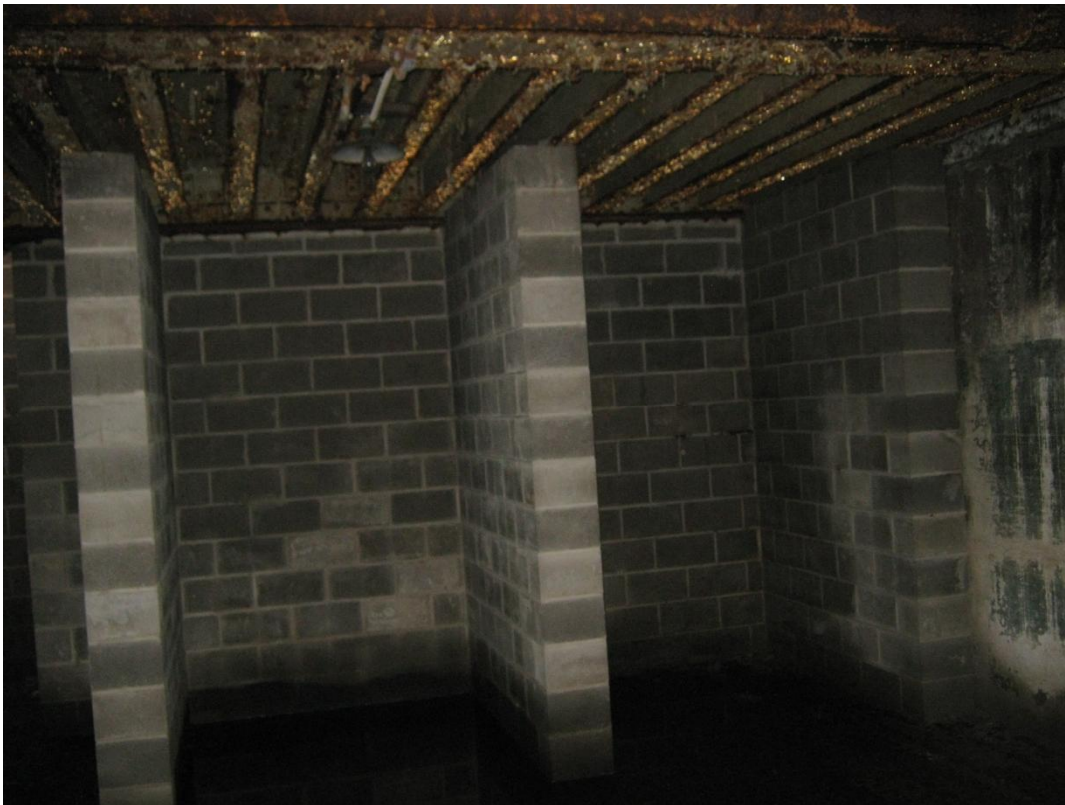
The inside of the baggage subway tunnel has significantly less scattered debris on the floor than the passenger tunnel. There is no evidence of a previously existing ceiling system and the steel roof structure is fully exposed. All elevator shafts which once served the baggage subway tunnel have been filled, and the north and south ends of the tunnel have been bulk headed with concrete blocks (Appendix A: Photos 33-36).
